Apple Inspections, LLC
P.O. Box 8521
St. Louis, MO 63126

Property Consulting Inspection Report

1234 Your St.
Your Town, MO 62345

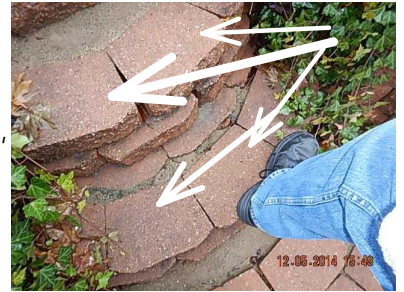
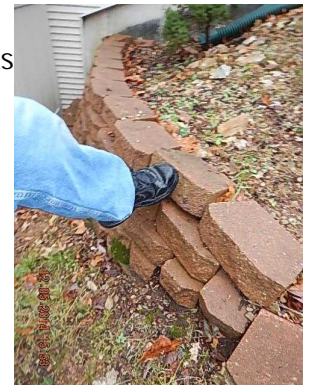
<u>Component</u>	<u>Material Type/Comments</u>
1. Grade/Slope: FUNCTIONAL	No improper conditions noted.
2. Grade Clearance at Walls: GENERAL MAINTENANCE	Soil contact, Vegetation
3. Downspout Drainage: FUNCTIONAL	On ground, Underground
4. Driveway/Walks: SAFETY CONCERN	Asphalt, typical settlement and deterioration noted. Regular maintenance of re-coating will extend the life., Decorative blocks, stones - -Decorations stones/block steps are not secured. are loose. Recommend properly securing by a qualified landscaping contractor.
5. Retaining Walls: SAFETY CONCERN	Decorative blocks - -Top row of decorations stones/blocks are not secured. Recommend properly securing by a qualified landscaping contractor.

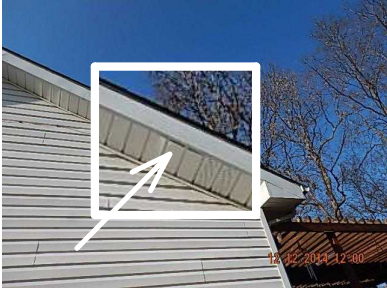
2. Soffits/Fascia/Trim: MARGINAL	Aluminum/vinyl covered - -Some loose/missing trim noted. Securing or re-installing may be needed in some areas.

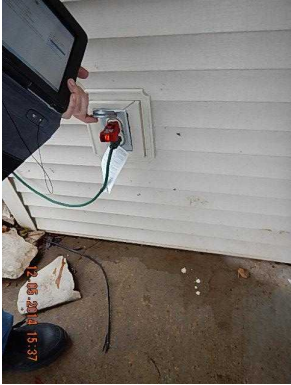
3. Guttering: FUNCTIONAL	Aluminum	
4. Downspouts: FUNCTIONAL	Aluminum	
5. Electric/Outlets: SAFETY CONCERN	Outlets found at, Front, rear - -A "grounded" type receptacle is present at rear patio but the circuit is not properly grounded. GFCI protection at this outlet would be considered a proper repair for this condition

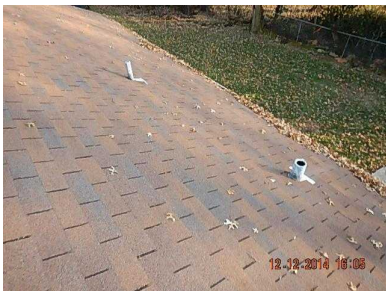
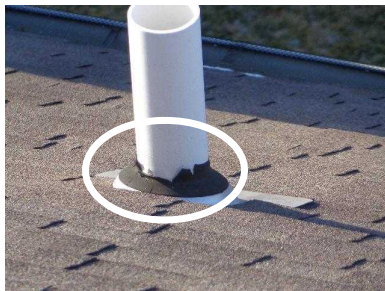
5. Flashings: MARGINAL

Metal/Lead, Metal/rubber; Rubber/Vinyl plumbing boots have a life expectancy of 8-10 years. Periodic inspection for cracking/deterioration is recommended.
-Rubber "boots" at plumbing vents are deteriorated. We recommend further repair or replacement as needed.

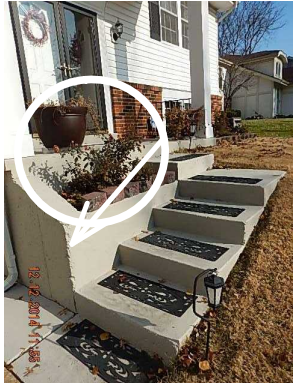
2. Condition/Observations: FUNCTIONAL	No improper conditions noted.	
3. Safety Conditions: SAFETY CONCERN	No handrail at steps, Add guard rail and balusters - -More than 3 steps noted with no handrail; recommend adding rail as safety measure. -Recommend adding guard railing and balusters along porch.

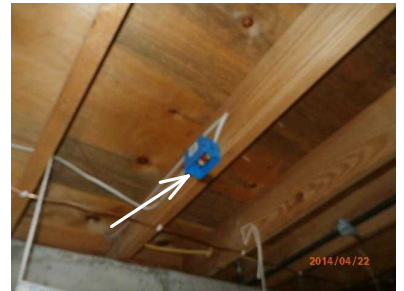
9. Electrical Conditions: SAFETY CONCERN

Open Junction boxes

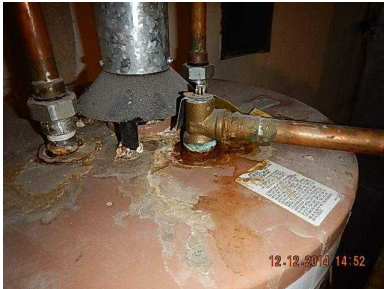
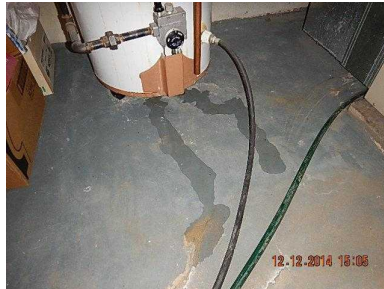
3. Operations/Connections: DEFECTIVE

Leak at supply, Tank leaking -
Tank leaking; replacement of unit is recommended.

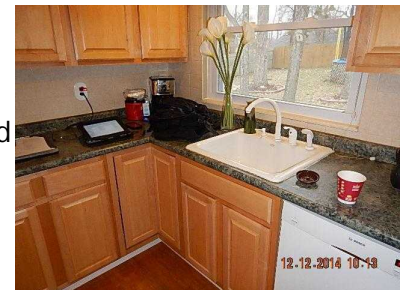
9. Cabinets & Countertops: MARGINAL	Wood cabinets, Formica top - -Loose counter top present at left side of electric range, a repair is recommended.

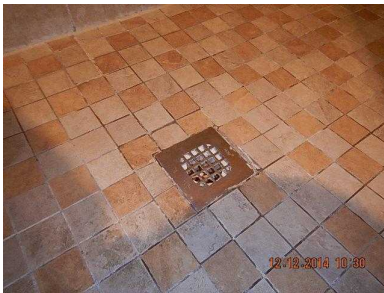
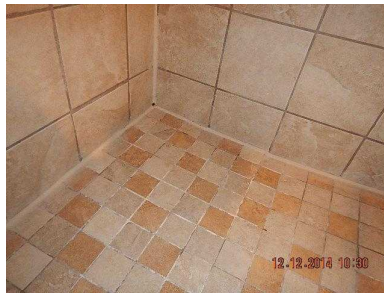
<u>Component</u>	<u>Material Type/Comments</u>
5. Observations: [info]	No improper conditions noted
6. Fixtures: GENERAL MAINTENANCE	Shower, Single vanity - -Some caulking/grouting recommended at shower.

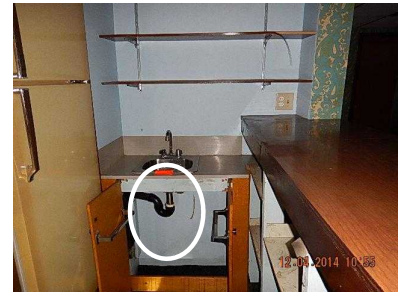
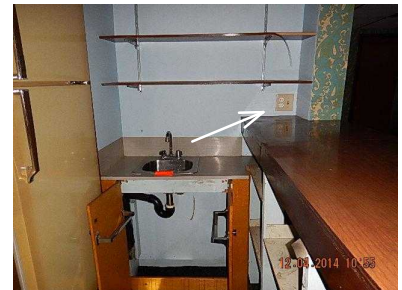
<u>Component</u>	<u>Material Type/Comments</u>
1. Location:	Bar Area, Basement level
2. Fixtures: DEFECTIVE	Wet Bar - -An active leak was noted on the drain line and repair is recommended.
3. Outlet(s): SAFETY CONCERN	GFCI recommended - -A "grounded" type receptacle is present but the circuit is not properly grounded.

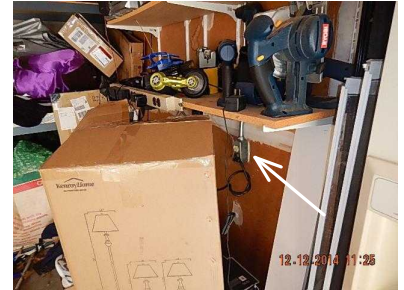
12. Electrical: SAFETY CONCERN

GFCI recommended -
-It is recommended that all receptacles (except ceiling) be connected on a GFCI circuit for safety.

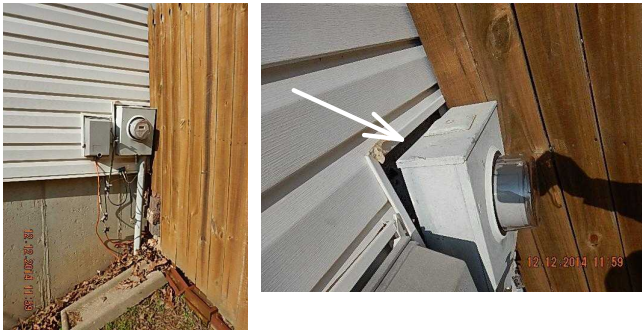
1. Exterior Service: SAFETY CONCERN

Exterior meter, Under ground -
-The exterior electric meter has pulled/separated away from the exterior wall/conduit. No slip coupling is visible on the conduit below the electric meter. Recommend having a licensed electrician install a slip coupling and secure meter base to the wall. Absence of an operable slip coupling causes this issue with ground movement. A slip coupling may not have been required when the dwelling was constructed, but is needed in a visible area to properly correct and prevent recurrence.

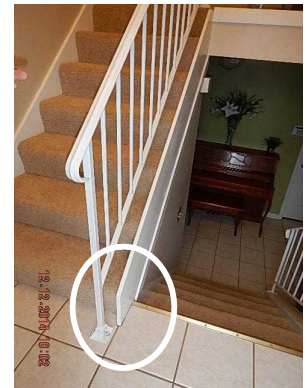
<u>Component</u>	<u>Material Type/Comments</u>
1. Doors & Windows: COMMENTS	Insulated glass, Vinyl windows - -Missing window screens were noted at various locations.
2. Walls & Ceilings: FUNCTIONAL	Drywall
3. Floors: FUNCTIONAL	Carpet, Vinyl/sheet goods, Hardwood
4. Stairwells: SAFETY CONCERN	Loose railing - -Loose hand rail noted at front stairwell and a repair is recommended.
5. Other: MARGINAL	Dimmer switch, control - -Dimmer switch not operating properly at dining room. a repair is recommended
6. Smoke Detectors (R): [info]	Present

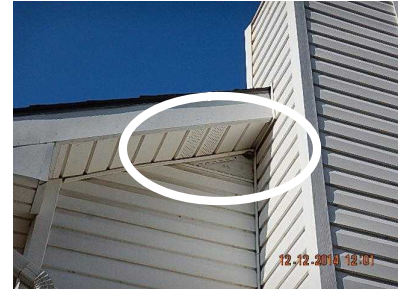
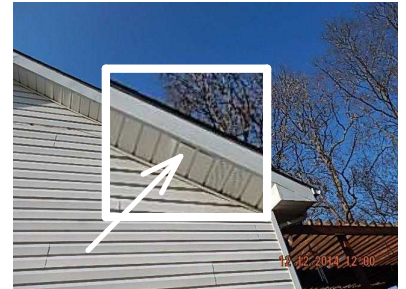
1. Exterior Finish (R): Brick/Stone Veneer, Vinyl - -Some missing siding noted (considered minor). A repair is recommended.
2. Soffits/Fascia/Trim: Aluminum/vinyl covered - -Some loose/missing trim noted. Securing or re-installing may be needed in some areas.

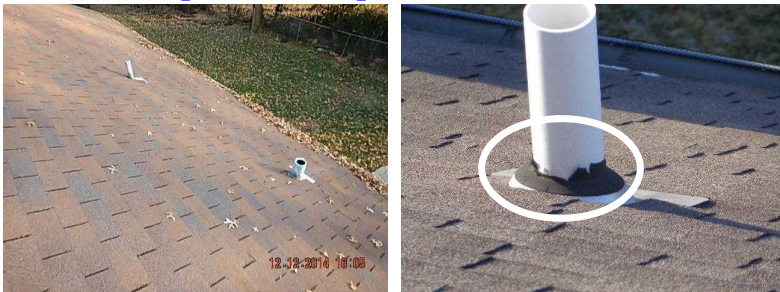
3. Flashings: Metal/Lead, Metal/rubber; Rubber/Vinyl plumbing boots have a life expectancy of 8-10 years. Periodic inspection for cracking/deterioration is recommended. -Rubber "boots" at plumbing vents are deteriorated. We recommend further repair or replacement as needed.

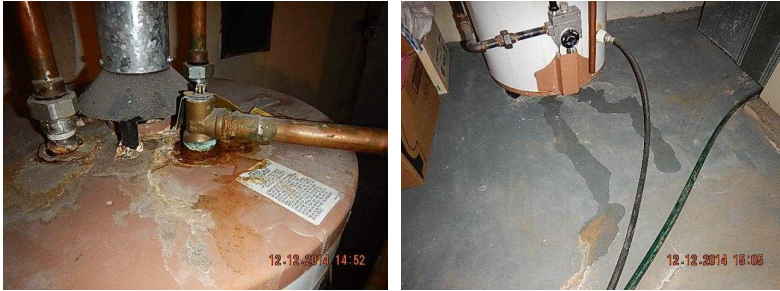
1. Operations/Connections: Leak at supply, Tank leaking - Tank leaking; replacement of unit is recommended.

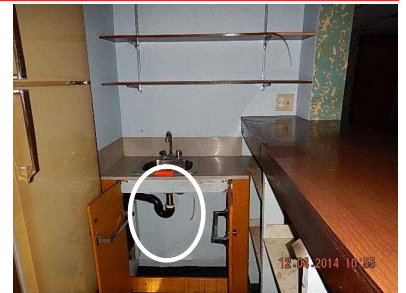
2. Fixtures: Wet Bar - -An active leak was noted on the drain line and repair is recommended.

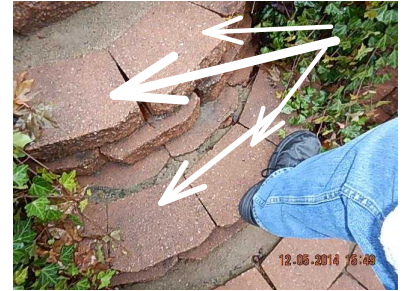
1. Driveway/Walks: Asphalt, typical settlement and deterioration noted. Regular maintenance of re-coating will extend the life., Decorative blocks, stones - -Decorations stones/block steps are not secured. are loose. Recommend properly securing by a qualified landscaping contractor.

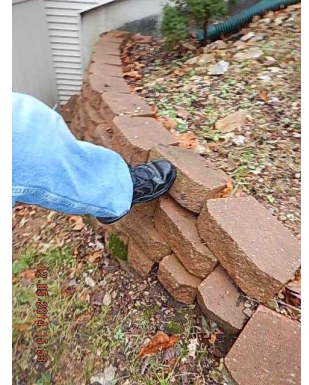
2. Retaining Walls: Decorative blocks - -Top row of decorations stones/blocks are not secured. Recommend properly securing by a qualified landscaping contractor.

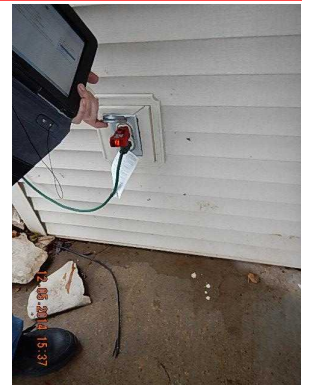
3. Electric/Outlets: Outlets found at, Front, rear - -A "grounded" type receptacle is present at rear patio but the circuit is not properly grounded. GFCI protection at this outlet would be considered a proper repair for this condition

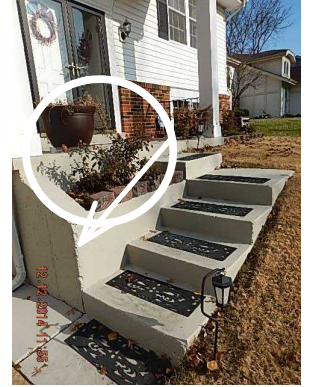
4. Front Porch Safety Conditions: No handrail at steps, Add guard rail and balusters - -More than 3 steps noted with no handrail; recommend adding rail as safety measure.
-Recommend adding guard railing and balusters along porch.

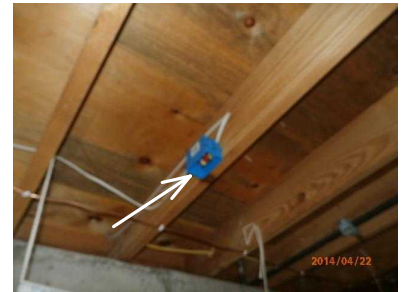
5. Electrical Conditions: Open Junction boxes

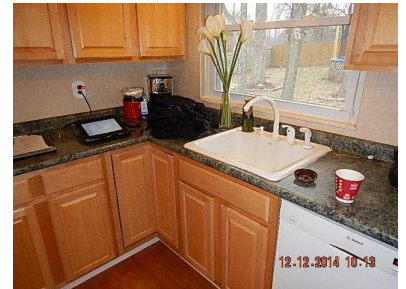
6. Range/Oven: Electric - -Recommend adding ant-tip device for safety prior to closing.
7. Electrical Outlets: GFCI outlets present, Additional GFCI outlets needed - -Additional GFCI protection is recommended; It is recommended that all receptacles along the kitchen counter top and at the island (except refrigerator) be GFCI or be connected on a GFCI circuit for safety.

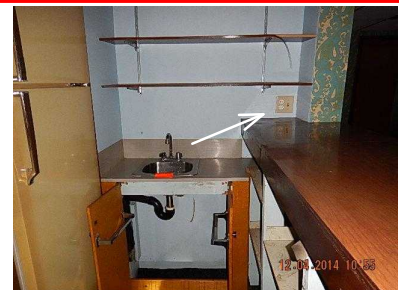
8. Outlet(s): GFCI recommended - -A "grounded" type receptacle is present but the circuit is not properly grounded.

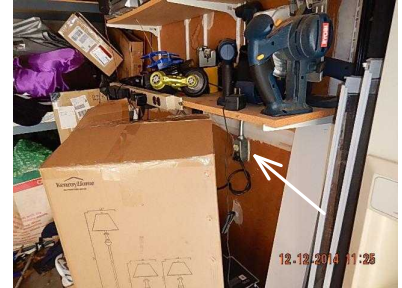
9. Firewall: No improper conditions noted.
10. Electrical: GFCI recommended - -It is recommended that all receptacles (except ceiling) be connected on a GFCI circuit for safety.

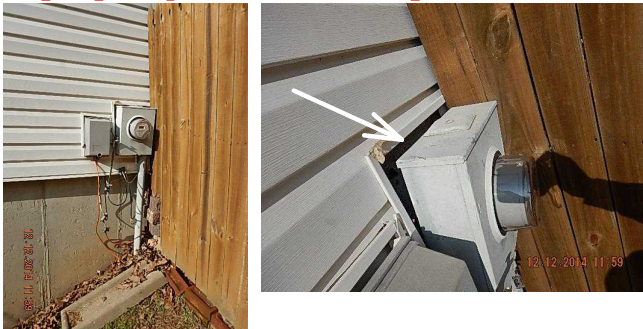
11. Exterior Service: Exterior meter, Under ground - -The exterior electric meter has pulled/separated away from the exterior wall/conduit. No slip coupling is visible on the conduit below the electric meter. Recommend having a licensed electrician install a slip coupling and secure meter base to the wall. Absence of an operable slip coupling causes this issue with ground movement. A slip coupling may not have been required when the dwelling was constructed, but is needed in a visible area to properly correct and prevent recurrence.

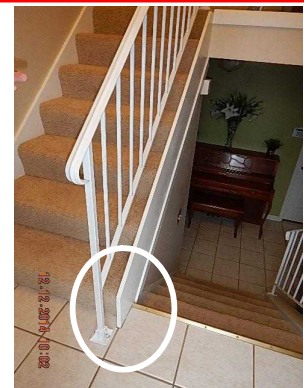
12. Stairwells: Loose railing - -Loose hand rail noted at front stairwell and a repair is recommended.
